RICS Home Surveys

Survey level two: HomeBuyer report – Survey and Valuation

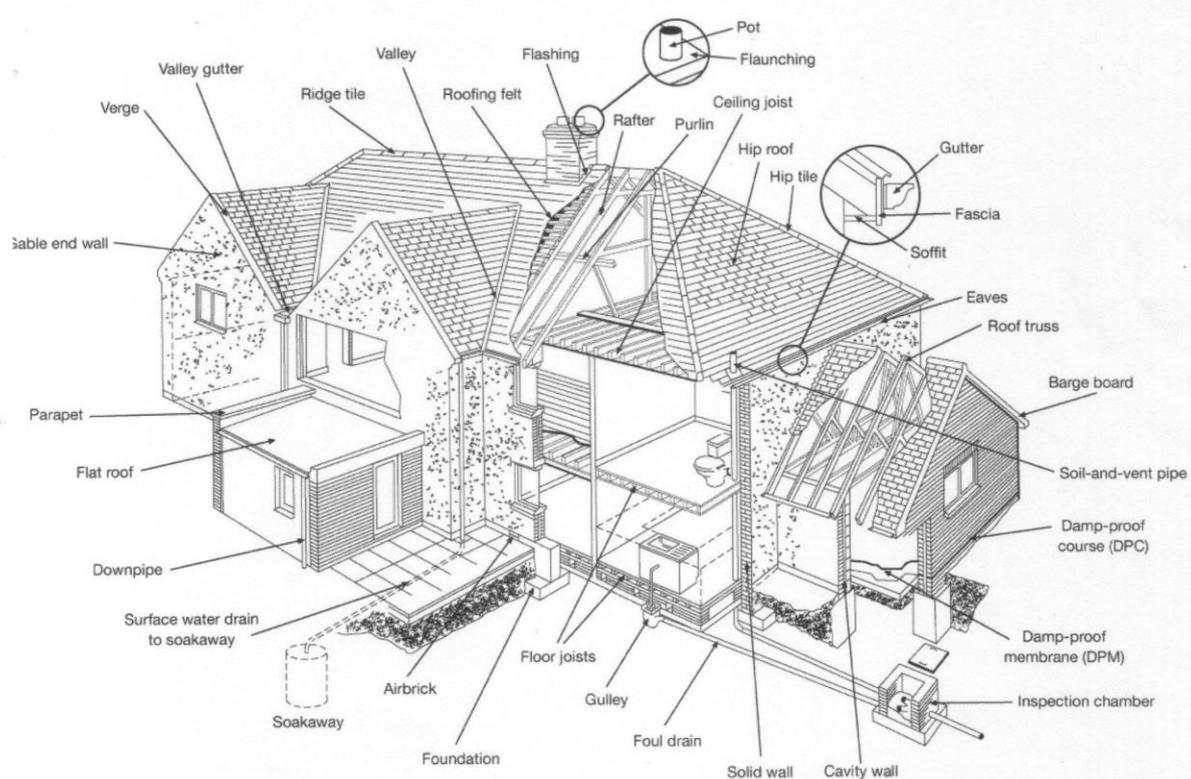
Typical house diagram

This diagram illustrates where you may find some of the building elements referred to in the report
